LARGE COMMERCIAL PASSENGER VESSEL PERMITTED / WASTEWATER DISCHARGE UNDERWAY INSPECTION REPORT Alaska Department of Environmental Conservation Division of Water		Form: AK-LCPV-D
			Last Updated 4/21/2025

1: General Information			
Inspection Date: 8/22/25-8/23/25		Vessel Name: Zaandam	
GP Auth # 2013DB0004-0052	Registration # 2025-CS-0015 v 1.0	IMO #.: 9156527	
Inspection: <input checked="" type="checkbox"/> Announced <input type="checkbox"/> Unannounced Type: <input checked="" type="checkbox"/> Routine <input type="checkbox"/> Other: Describe		Location: (Port City/Dock): Juneau, AK/CT Dock	
Arrival Time (at vessel): 8/22/25 16:25	Inspection Start Date and Time: 8/22/25 16:45	Inspection End Date and Time: 8/23/25 6:00	
Comments Regarding Access (if any): None.			
Opening Meeting: The opening meeting was attended the Environmental Officer and Chief Engineer. The inspector presented their credentials and informed them that the Department was performing a routine inspection assessing permit compliance and discussed the scope and objectives of the inspection. The inspector informed them that they would need access to machinery spaces, the engine control room, and possibly other secure a

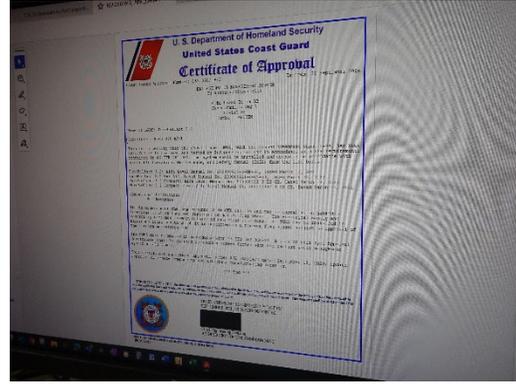
Photo 02

USCG Ballast water approval

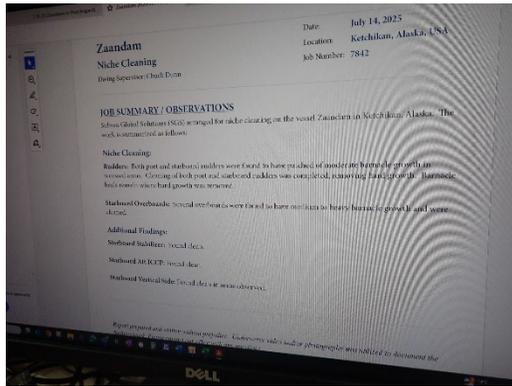
Photo 03

Niche cleaning July 14, 2025

Photographic report from most recent underwater hull inspection/survey available
(See photo 03)

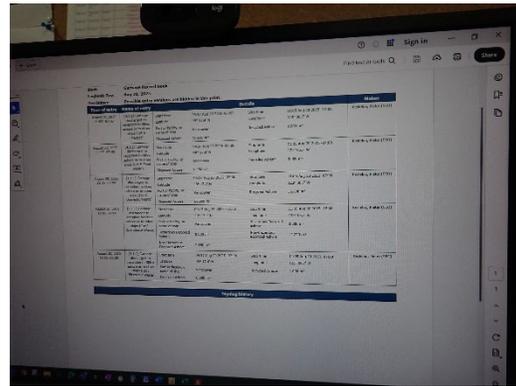
Photo 04

NAPA Garbage Record Book

Garbage Record Book reviewed (Photo 04)

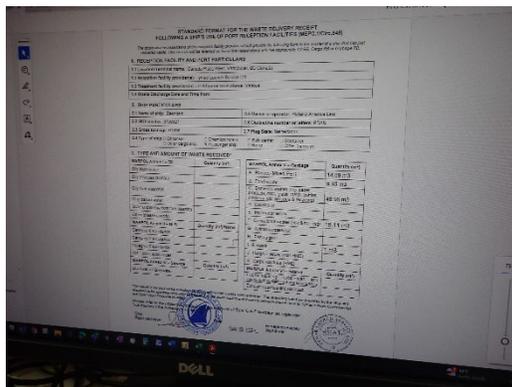
Photo 05

Tarmac receipt 8/20/25

Waste offload receipts correlate to record book entries (Photo 05)

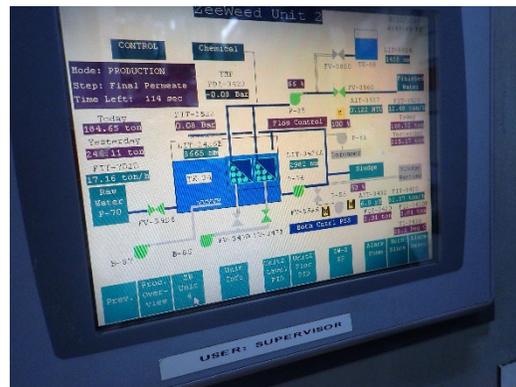
Photo 06

AWT's local control panel

At 18:20, the inspector visited the machinery space to look at the AWTS system and local control panel. Following the inspection of the machinery space, the EO and inspector parted ways.

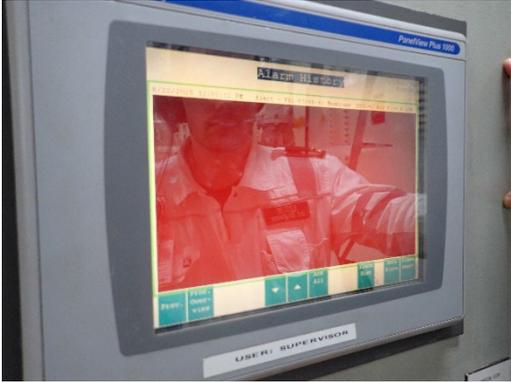
AWTS Alarm panel	Quantum of the Seas underway from Marine Park
Photo 09	Photo 10

The AWTS system components were observed to be operational. Piping and system components were observed to be free of visible corrosion and in good repair. No leaks or foul odors were observed. One low priority alarm was active on the local alarm panel which indicated low air flow in one of the membranes.

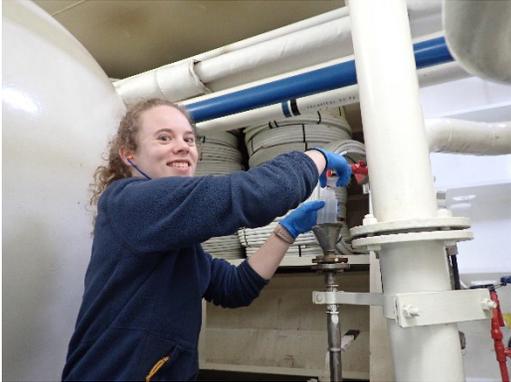
AE Sampler	Environmental permissions screen
Photo 11	Photo 12

The inspector, sampler from Admiralty Environmental, and EO met at 3:30 the following morning to conduct the AWTS sampling. The inspector verified the location of the sampling point and witnessed the sample at about 4:00.

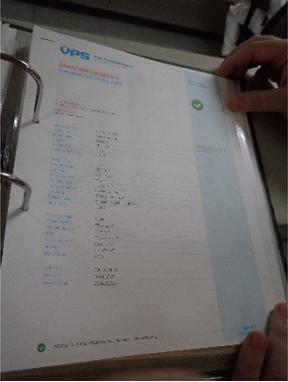
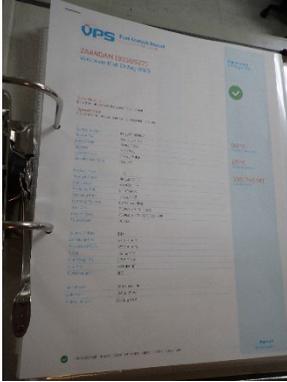
Vancouver 8/13/25 250MT 0.0007% sulfur	Vancouver 8/13/25 200MT 1.6200% sulfur

On 8/13/25, the ship bunkered approximately 200 MT of HFO with a sulfur content of 1.6200% and approximately 250 MT of MGO with a sulfur content of 0.0007%.
