LARGE COMMERCIAL PASSENGER VESSEL  PERMITTED / WASTEWATER DISCHARGE UNDERWAY INSPECTION REPORT Alaska Department of Environmental Conservation Division of Water		Form: AK-LCPV-D
			Last Updated 4/21/2025
<b>1: General Information</b>			
Inspection Date: 7/23/25-7/24/25		Vessel Name: Ruby Princess	
GP Auth # 2013DB0004-0005	Registration # 2025-CS-0046 v1.0	IMO #.: 9378462	
Inspection: <input checked="" type="checkbox"/> Announced <input type="checkbox"/> Unannounced Type: <input checked="" type="checkbox"/> Routine <input type="checkbox"/> Other: Describe		Location: (Port City/Dock): Ketchikan, AK/Dock 4 to Haines, AK/CHL Dock	
Arrival Time (at vessel): 7/23/25 10:40	Inspection Start Date and Time: 7/23/25 10:50	Inspection End Date and Time: 7/24/25 13:00	
Comments Regarding Access (if any): None.			
Opening Meeting: The opening meeting was attended by the Staff Captain and Environmental Officer. The inspector presented their credentials and informed them that the Department was performing a routine inspection assessing permit compliance and discussed the scope and objectives of the inspection. The inspector informed them that they would need access to machinery spaces, the engine c

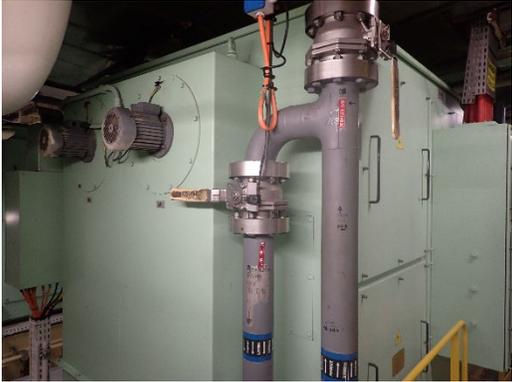
Photo Addendum	
<b>Photo 01</b>	<b>Photo 02</b>

Ruby Princess (from American Const. tender)	AWWTS piping route to o/b or holding
<b>Photo 03</b>	<b>Photo 04</b>

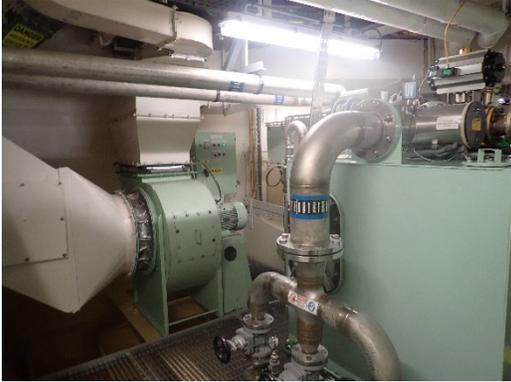
UV	Garbage offload receipt
<b>Photo 05</b>	<b>Photo 06</b>

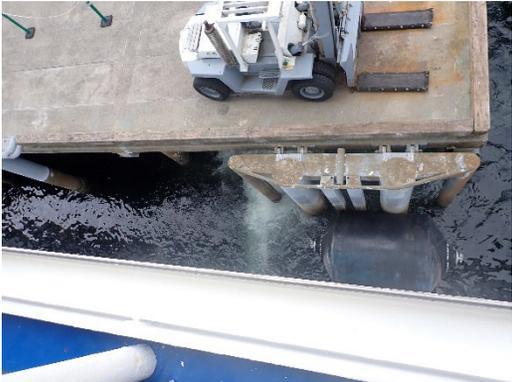
At 14:40, the inspector and EO toured the outer decks. The inspector inquired about the discharge seen in Photo 06 & 07 and the EO identified the discharge to be EGCS washwater. The discharge appeared to have a significant volume. As the ship got underway, the inspector continued to view the water on the starboard side while the ship was maneuvering. No sheens were observed.

Garbage recordbook	EGCS Discharge KTN
