| | LARGE COMMERCIAL PASSENGER VESSEL PERMITTED / WASTEWATER DISCHARGE UNDERWAY INSPECTION REPORT Alaska Department of Environmental Conservation Division of Water | | Form: AK-LCPV-D |
| Inspection Date: 9/2/25-9/3/25 | | Vessel Name: Discovery Princess | |
| GP Auth # 2013DB0004-0041 | Registration # 2025-CS-0048 v1.0 | IMO #.: 9837468 | |

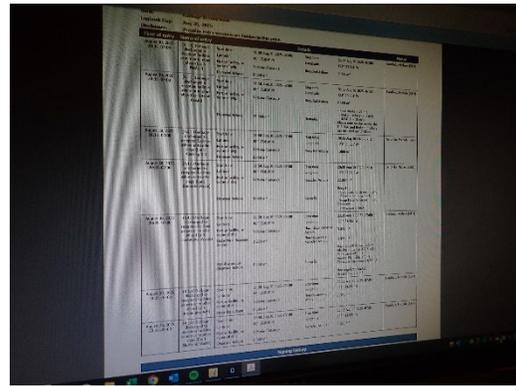
Photo 02

NAPA log garbage record book

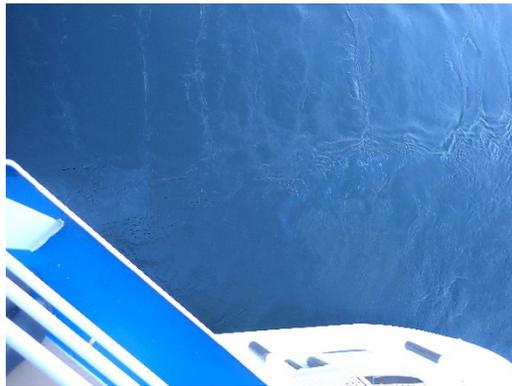
Photo 03

Seen just after departing Ketchikan (starboard aft)

The inspector met with the Environmental Officer and reviewed paperwork, garbage logs, and food waste disposal procedures. After the ship got underway from the dock the inspector and EO visited the outer decks. Sheens were noticed along the starboard side, the source of which was unclear, though the sheens had similar characteristics to EGCS washwater sheens. When the inspector inquired about EGCS wash water compliance data, the EO denied the inspector access to Neptune data. The EO informed the inspector that there were no exceedances recorded by the compliance computer at the time the sheen was noticed.

After touring the outer decks, the inspector met briefly with the Master to discuss the sheen seen upon departure. He suggested the source may be from the nearby float plane dock. The inspector reviewed the biofouling logbook in NAPA, biofouling reports, and ballast water information.

The sheens witnessed by the inspector were reported both to EPA Region 10 and the U.S. Coast Guard National Response Center for further review. The Vessel General Permit (or VGP, the permit which regulates scrubber discharges) Part 2.2.26 states that “Exhaust gas scrubber wash water discharge must not contain oil, including oily mixtures.”

The master had informed inspector that he didn’t believe that the sheens were not from the EGCS. If the water was discharged from a different source, this sheen would have needed to be reported to the USCG, which it was not.

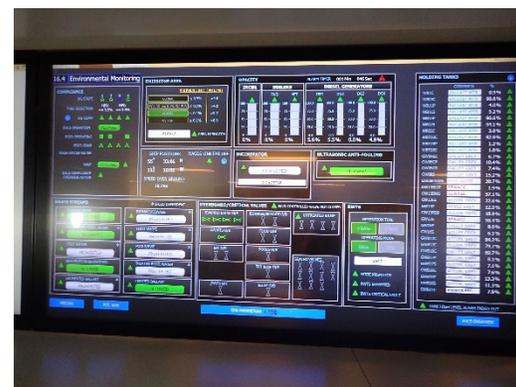
Photo 06

Environmental Monitoring screen

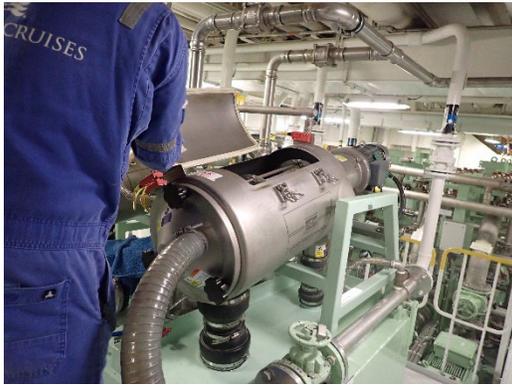
Photo 07

Interstage filter cleaning

The inspector visited the ship's technical office and reviewed waste receipts and fuel bunkering receipts. Then, with the 1st engineer and EO, the inspector toured the machinery spaces and inspected the MBR systems. At the time of inspection, maintenance by MBR plumbers was underway, including a manual cleaning of the interstage filter and a cleaning/flushing of one of the membrane banks. The inspector also viewed the permeate overboard point and sampling point.

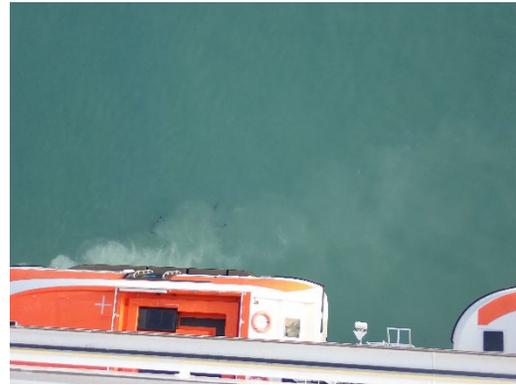
Photo 08

Black chunks with EGCS wash water

The next morning, the inspector toured the outer decks as the ship navigated through Endicott Arm to the Dawes Glacier. The inspector monitored the EGCS washwater discharge point on the starboard side. At approximately 7:22, the inspector photographed black clumps in the water coming from the EGCS wash water discharge point. The inspector documented this with photos and video and immediately called the Environmental Officer.

Later, the inspector met with the EO and Master to discuss the black clumps. The Master reviewed internal CCTV footage and wasn't able to see the same sooty clumps from the same vantage point the inspector had and was not able to find footage that matched the inspector's photos. There was some discussion about the possible source of black soot in the water. Vessel schematics and engineers were consulted to match the location of the discharge with the EGCS washwater discharge point. The master and EO informed the inspector that there were no compliance exceedances during that time, nor during the entire time the ship was in Endicott Arm. The inspector was not permitted to review the compliance data to verify that there were no exceedances.

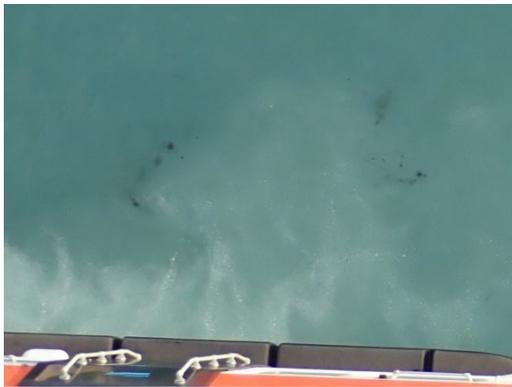
Photo 09

Black chunks with EGCS wash water zoomed in
